Household Perceptions of Shelter Safety in Typhoons and Earthquakes:

Takeaways from Leyte and Eastern Samar Six Years After Typhoon Yolanda

March 2020

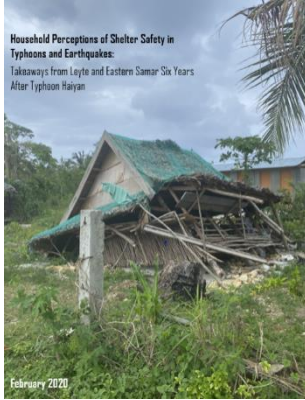
A shelter in Eastern Samar which collapsed during Typhoon Ursula in December 2019.

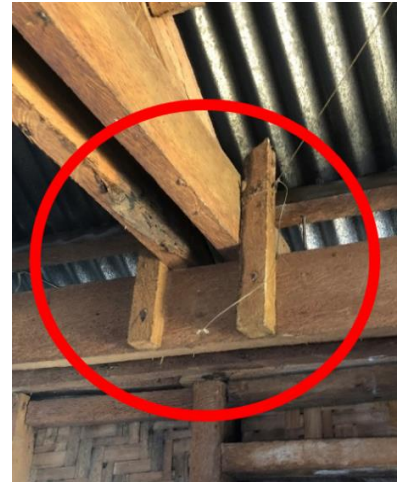
Figure 11: Truss-wall connection in Community C wooden shelter.

With the exception of Community B and the wooden shelter in Community C, the expected roof failure mechanism is the failure of the purlin-truss connections (see Figure 11). This is the second-most preferred type of failure, for the failure of these connections and subsequently the CGI panels will save the rest of the roof system, mainly the truss. In Community B, the CGI panel-purlin connections are expected to be the first failure of the roof components, also leading to the removal of the CGI panels. In the case of the wooden shelter in Community C, the failure of the truss-wall connection first is not preferred and is likely to lead to the damage and potential collapse of the entire roof system, significantly decreasing the safety of these shelters. Compared to the other shelter designs, the trusses in the wooden shelters in Community C are connected to the wall using only small wooden cleats (see Figure 10) – a weak and vulnerable connection that should be replaced with either bolts or wind straps.

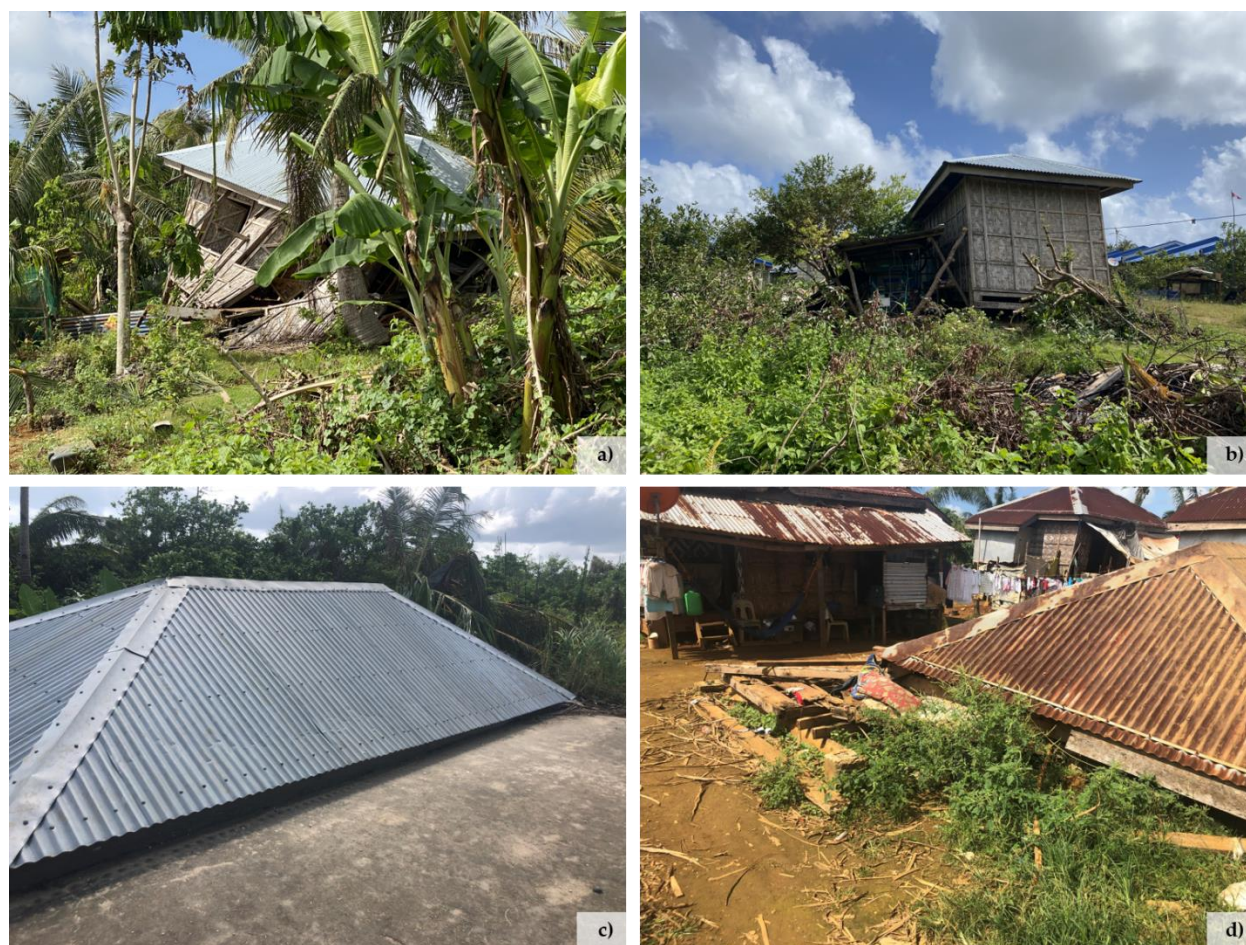
Figure 12: Examples of shelters that experienced wall failure due to failure of the column-foundation connection. a-b) Wall racking led to tilt and partial collapse. c-d) Wall racking led to complete collapse with roofs landing on the shelter. (Photos a & b by Abbie Liel).

In Community B, the shape of the roof and the use of wind straps in connecting the purlins to the truss and the truss to the wall makes the roof strong compared to the walls. Thus, the wind speed at which the first wall failure occurs is less than the wind speed where any of the roof components fail, resulting in the least desired failure mode. The failure of the walls before any of the roof elements can

lead to considerable tilting and complete collapse (see Figure 12) – outcomes experienced by nearly 50 of the shelters in Community B during Typhoon Ursula, which struck Guiuan and Tacloban on December 24, 2019, with wind gusts up to 120 mph.

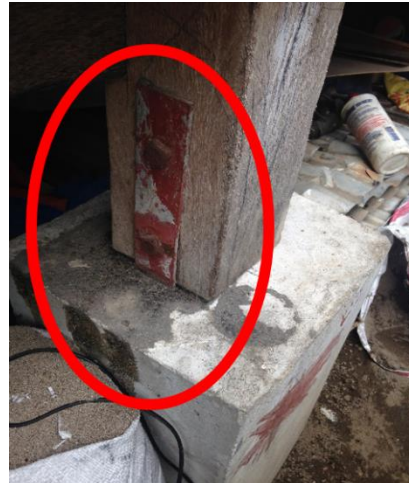
Figure 14: Example of metal strap connecting column and foundation.

While worries with the walls most often dealt with the durability of the wall panel material, it is a failure of the wall frame at the connection between the column and roof beam and the column and concrete foundation, that leads to wall damage and collapse. In Community B, our field reconnaissance indicates that it was a deterioration of the column at the connection with the foundation and a failure of the metal strap connecting the wooden column and concrete footing (see Figure 14) that led to collapse.

While households expressed concern with both the amakan wall material and the column-foundation connection, they were most concerned with and most likely to change the wall material. Only strengthening the wall panels could increase the forces on the wall frames and make the shelter more vulnerable to collapse. Organizations should discuss these consequences with households during training and encourage strengthening of the column-foundation connection.
