Household Perceptions of Shelter Safety in Typhoons and Earthquakes:

Takeaways from Leyte and Eastern Samar Six Years After Typhoon Yolanda

March 2020

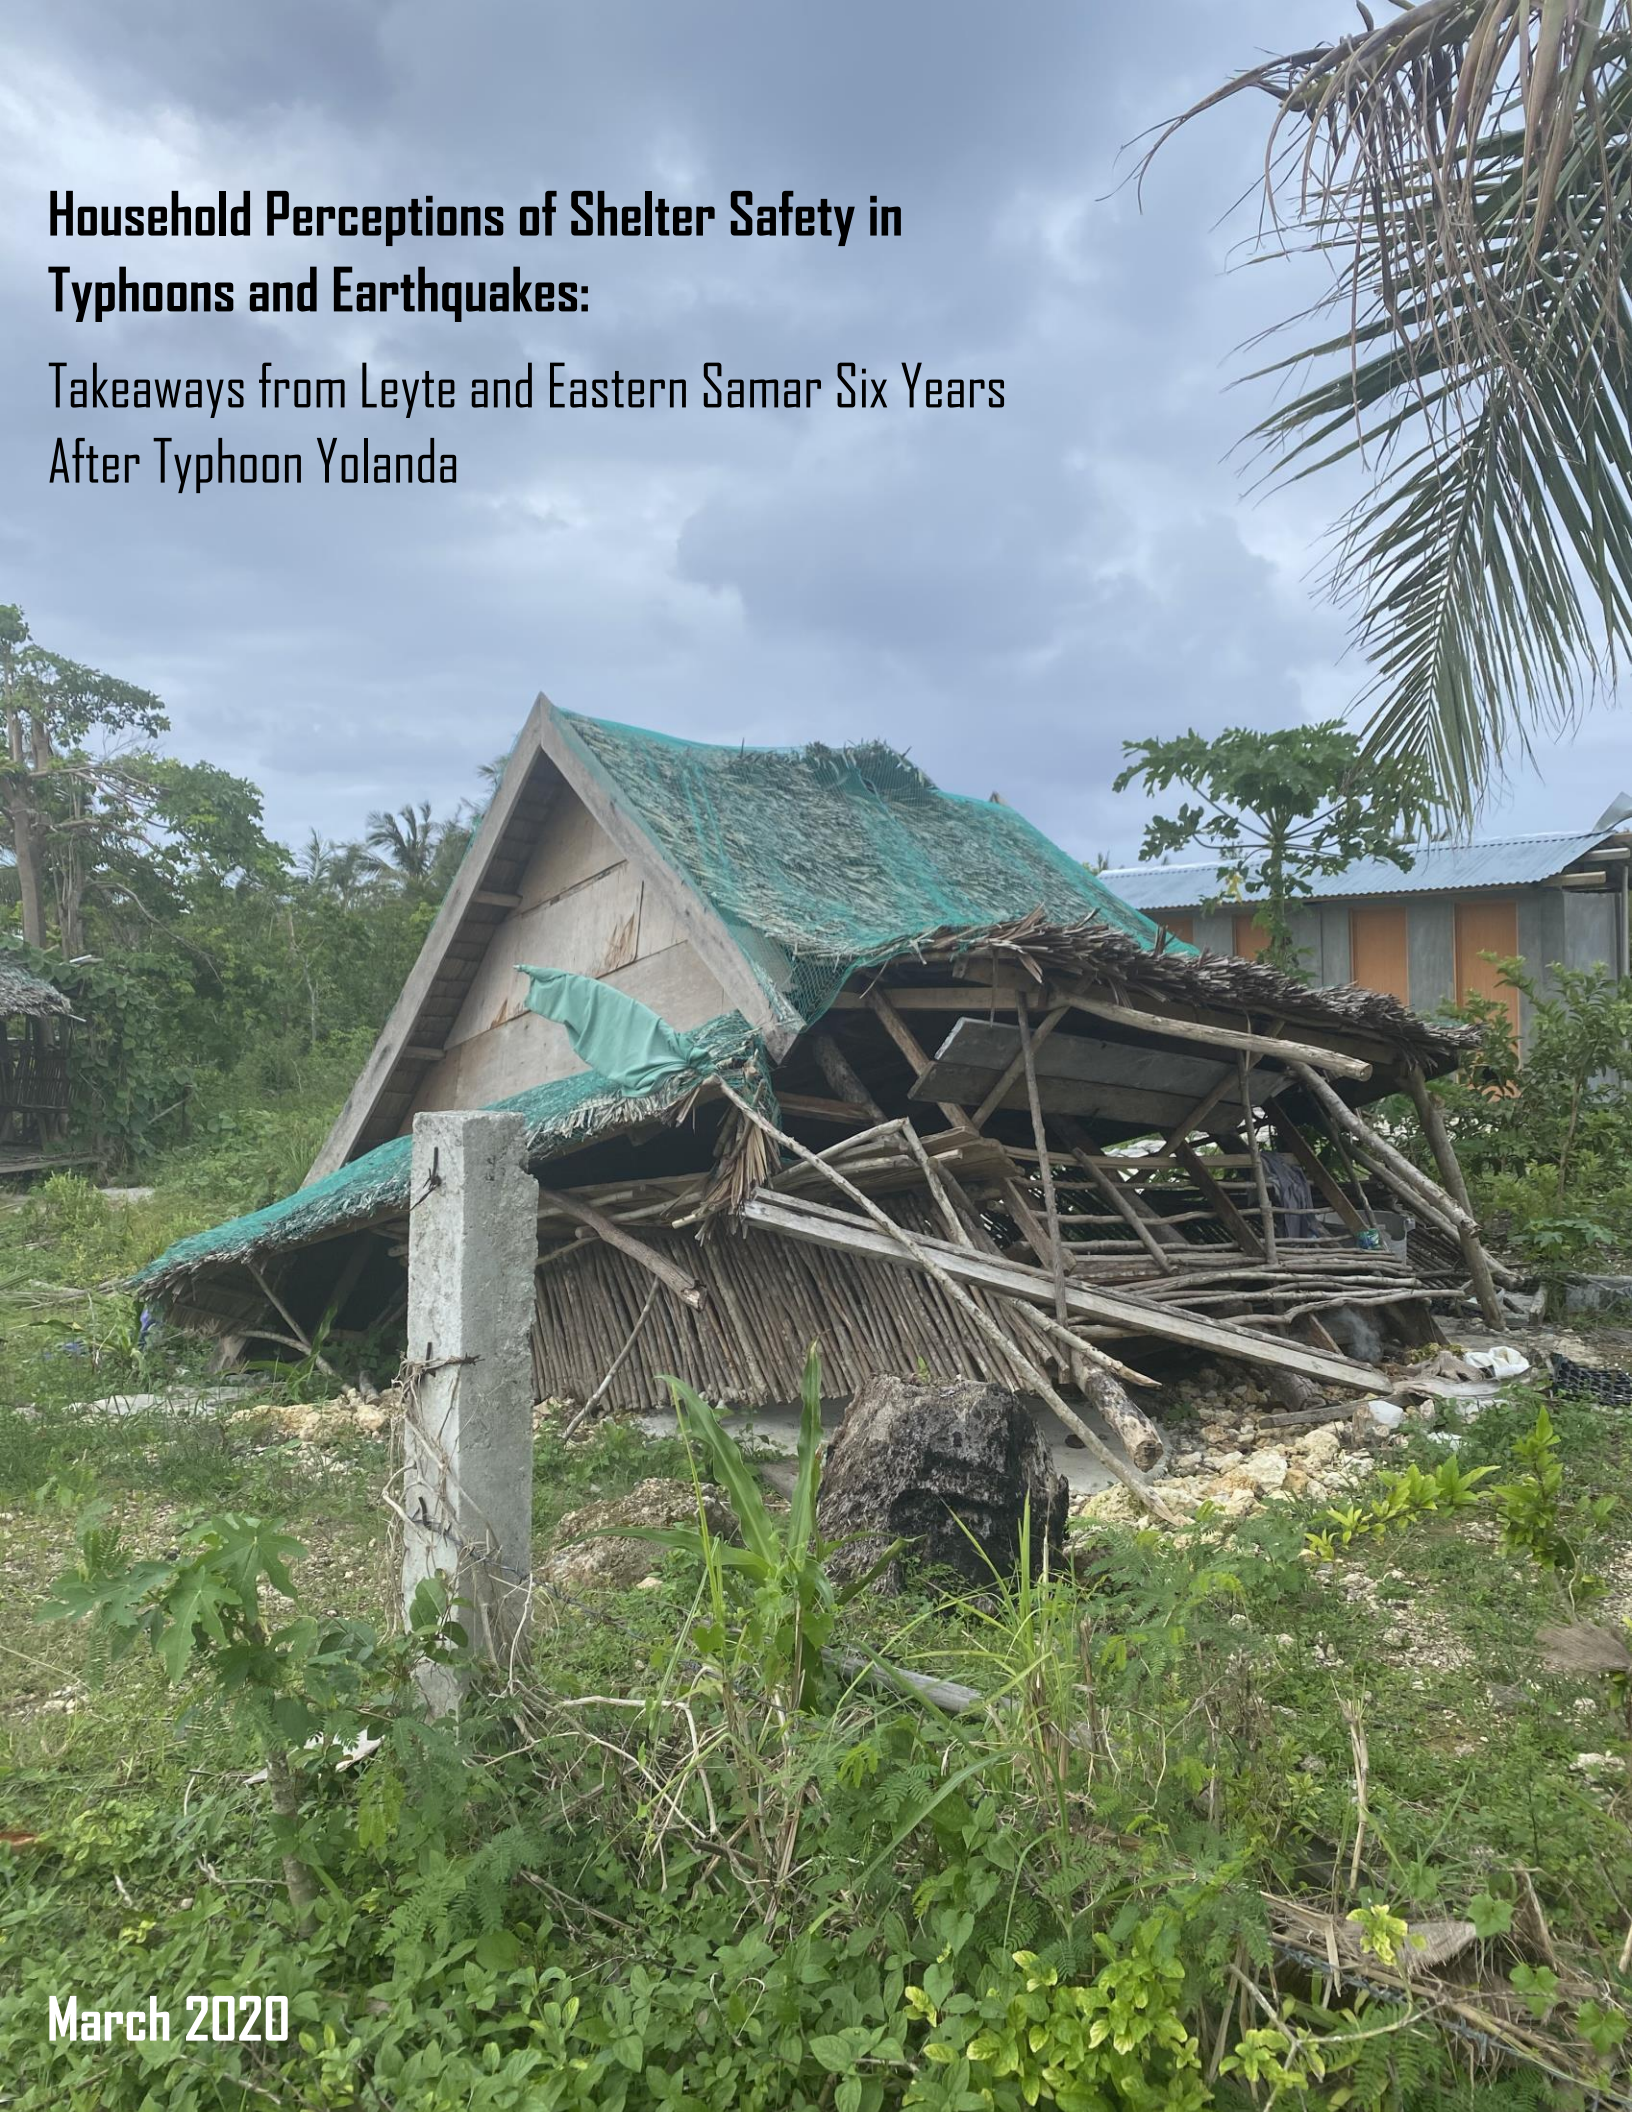
Cover

A shelter in Eastern Samar which collapsed during Typhoon Ursula in December 2019.

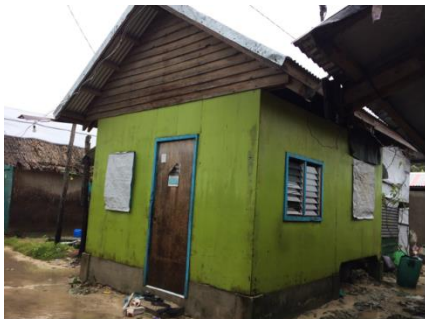
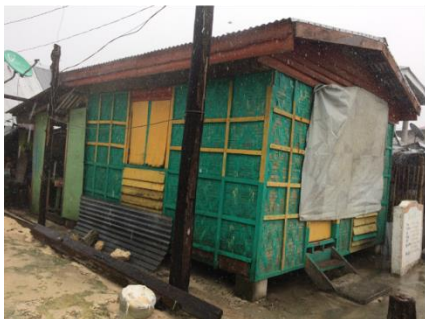
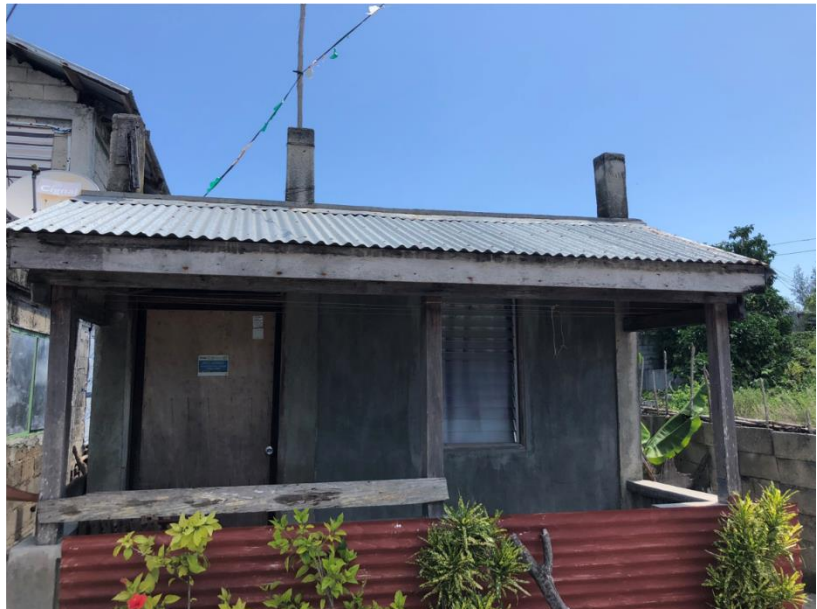
Shelter program details:	Households were responsible for securing materials and labor with cash received in a three-tranche system. Two INGOs provided shelter designs and used three different designs. Households reported varying levels of participation in the design and construction of their house.
Relocation site?	No
Structural system:	Coconut lumber or reinforced concrete
Wall material:	Amakan or plywood (coconut lumber frame), CMU (concrete frame)
Roof system:	Gable shape, CGI (coconut lumber frame); flat, concrete (concrete frame)
Key design elements:	Double cleats used to connect purlins to trusses and bolts used to connect trusses to columns (coconut lumber frame). Columns partially extended to allow for construction of second story (concrete frame).
Prevailing perceptions of safety:	Regardless of whether they lived in a concrete or wooden shelter, households expected the same level of damage to their shelter. The only considerable difference was expected damage to walls – those in concrete shelters expected less damage to walls than those in wooden shelters.

Important (mis)alignments:	Water intrusion was one of the biggest concerns in this community; therefore, the desired changes more often addressed how to stop water from leaking into the shelter instead of how to make the shelter safer from a structural perspective.

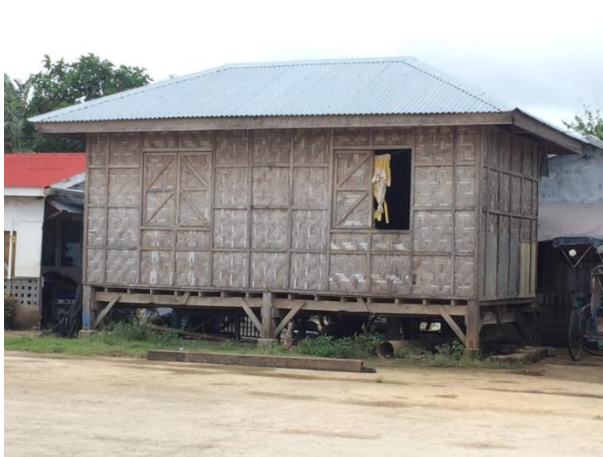
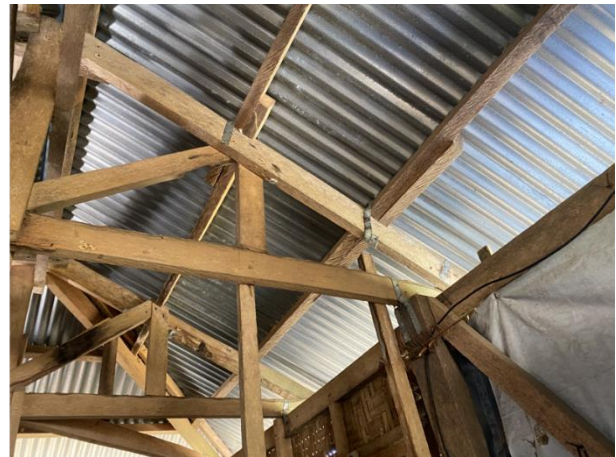
Community B

Shelter program details:	Core shelters designed by an INGO. Households participated in procuring coconut lumber and received varying amounts of training on construction and maintenance. Shelters were intended to last for 5 years with community members understanding that permanent houses would be provided after 5 years.
Relocation site?	No
Structural system:	Coconut lumber
Wall material:	Amakan
Roof system:	Hip shape, CGI
Key design elements:	Hurricane straps used to connect purlins to truss and truss to wall
Prevailing perceptions of safety:	Households perceived the entire shelter to be unsafe, particularly in typhoons. There was no confidence in the roof or the walls, driven largely by concerns with the quality of coconut lumber and amakan.
Important (mis)alignments:	Households underestimated the safety of the roofs of these shelters despite the roofs having multiple design elements that make them safe. Concerns with material quality drove perceptions regardless of improved design features.

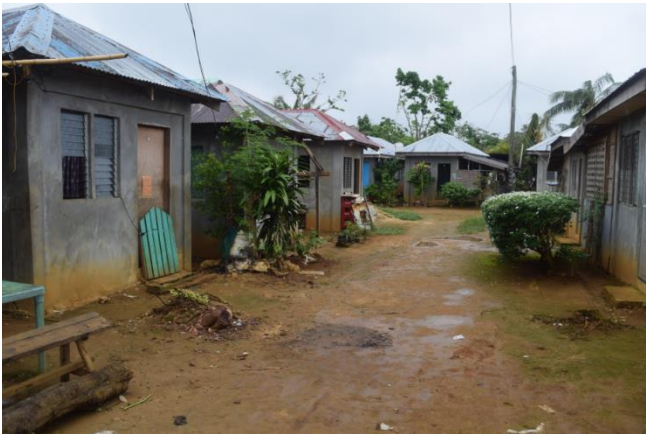
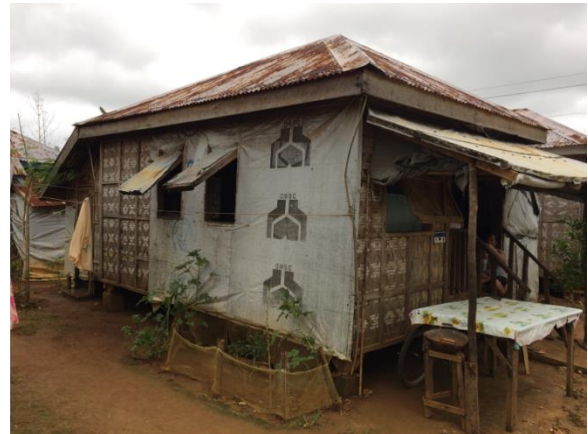
Community C

Shelter program details:	Transitional shelter provided by an INGO in partnership with local government. Local government has transitioned a portion of the shelters into permanent housing. Households did not participate in the design or construction of either the transitional shelter or permanent houses.
Relocation site?	Yes
Structural system:	Coconut lumber (transitional), reinforced concrete (permanent)
Wall material:	Amakan (transitional), CMU (permanent)
Roof system:	Hip shape, CGI (transitional and permanent)
Key design elements:	'Flat bar' connecting edge of roof panels to concrete piers (transitional), 'wrapped rebar' connection between concrete columns and wooden roof truss (permanent)
Prevailing perceptions of safety:	In general, households living in concrete shelters perceived their shelters to be safer than households living in wooden shelters, particularly as it relates to foundations and walls. Regardless of material, households expected the entire roof system to be destroyed in a typhoon.

Important (mis)alignments:	In this community it first became clear that there are different concerns with different types of hazards, and because of the duration of and need to stay inside during a typhoon, households preferred concrete to wood. Households acknowledge that concrete can be less safe in earthquakes, but their priority is having a shelter that is safe in a typhoon.

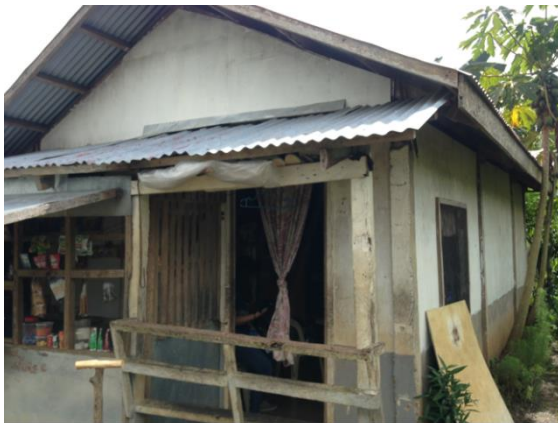
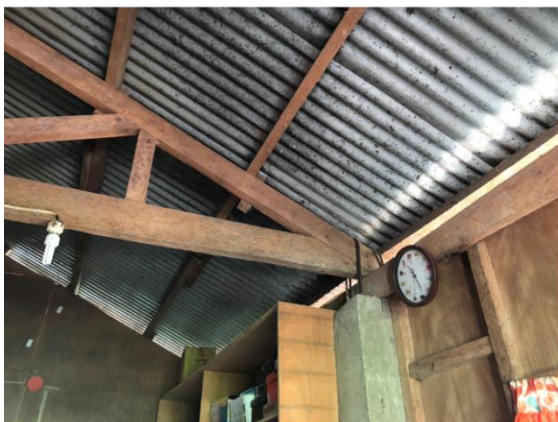
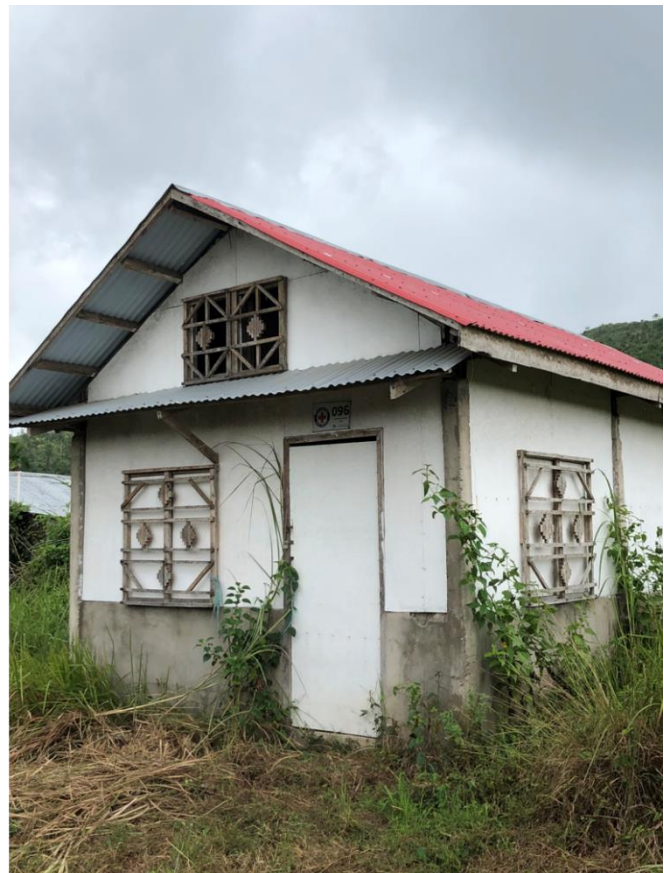
Community D

Shelter program details:	Core shelter provided to households who owned or could purchase plot of land. If shelter was not constructed in 10 days, households were responsible for finishing the construction.
Relocation site?	No
Structural system:	Reinforced concrete
Wall material:	Half-height CMU and plywood
Roof system:	Gable shape, CGI
Key design elements:	'Wrapped rebar' connection between columns and trusses. CMU skirt is not tied to concrete columns
Prevailing perceptions of safety:	Perceptions of safety were most divergent in this community. A majority of households expected the roof covering and structure to be damaged but not destroyed in a typhoon, and most did not expect the foundations or walls to be damaged.
Important (mis)alignments:	In this community, perceptions aligned most closely with engineering assessments. A common modification households wished to make was changing the walls of their shelter to full-height instead of half-height CMU. Because of the small columns in this shelter, this change could make the shelters more prone to damage, particularly in earthquakes.

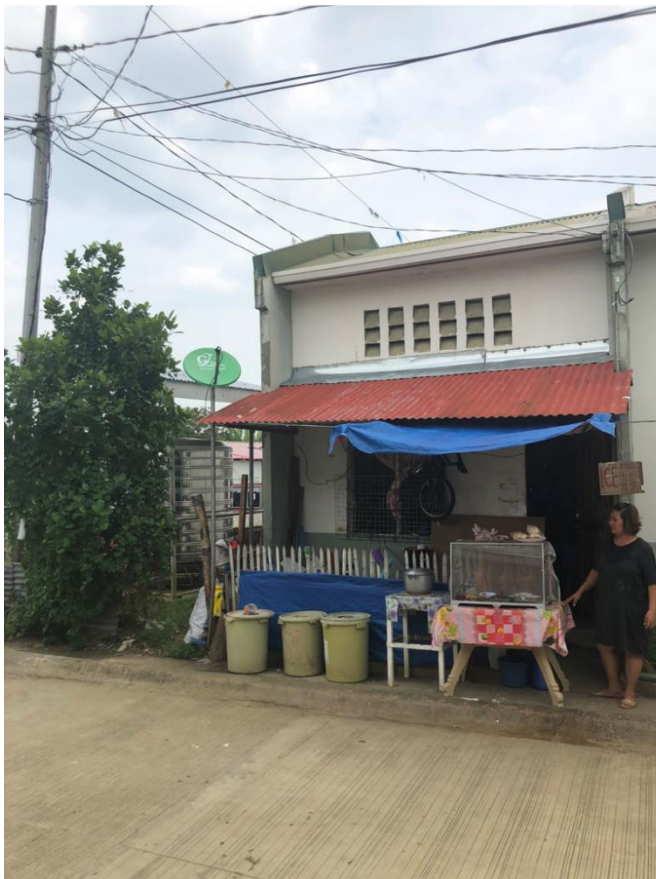
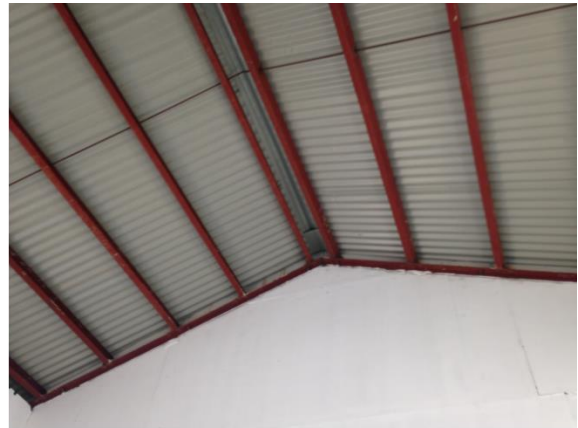
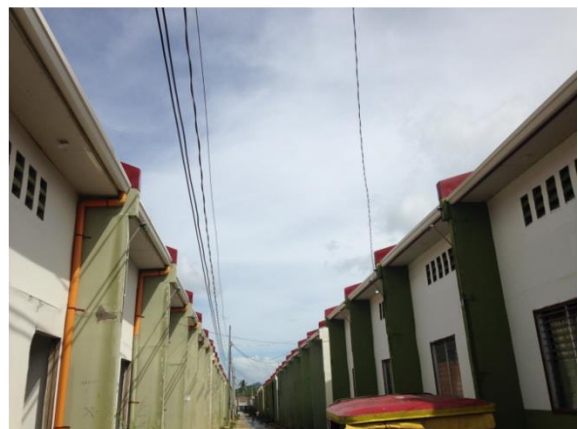
Community E

Shelter program details:	Row houses designed by the local government and constructed by government-hired contractor. Households had no participation in the design or construction and were assigned a shelter using a raffle system.
Relocation site?	Yes
Structural system:	Load-bearing walls
Wall material:	Reinforced concrete or hardiflex
Roof system:	Gable shape, CGI
Key design elements:	No roof trusses, steel purlins. Houses designed so that an internal second floor could be added.
Prevailing perceptions of safety:	Nearly all households expected the roof to be destroyed in a typhoon, and most expected the walls to be destroyed. The height of the walls, the shelters being connected to each other, and the construction quality were issues that influenced perceptions of safety. Security from robbery was a top concern.
Important (mis)alignments:	While households' concerns about construction quality and the safety of tall walls agreed with the engineering assessments, households likely underestimated the safety of their roofs. In this community, households were more concerned with damage from earthquakes, which aligns with assessments. Because of the height, poor concrete quality, and being connected to other shelters, earthquakes are more likely to cause damage.
